CRASH INJURY REPORT

U. S. ARMY U-1A
De HAVILLAND OTTER ACCIDENT
Fort Carson, Colorado
16 June 1959

Aviation Crash Injury Research
of the **F**light **S**afety **F**oundation

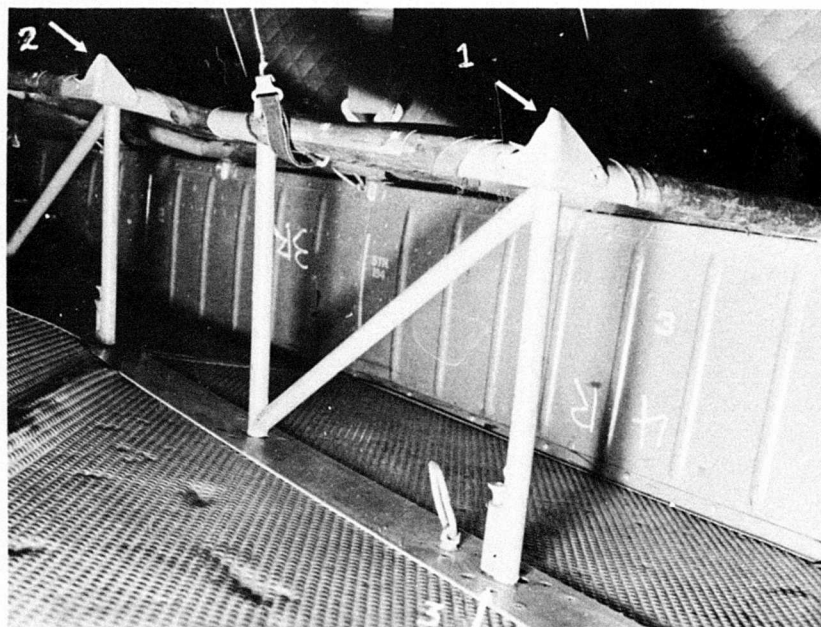
Fig. 52. Although torn completely free during the crash, seat 3R was placed in its normal position in the aircraft for this photograph.
